Durability of Posttensioned Concrete After 33 Years of Marine Exposure

Technical Report SL-97-9
September 1997

by Morris Schupack

Final report

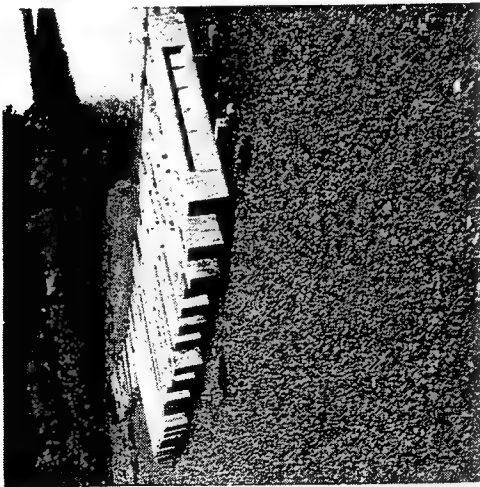
Fig. 2A

1962 - 20 Beams placed in 1961

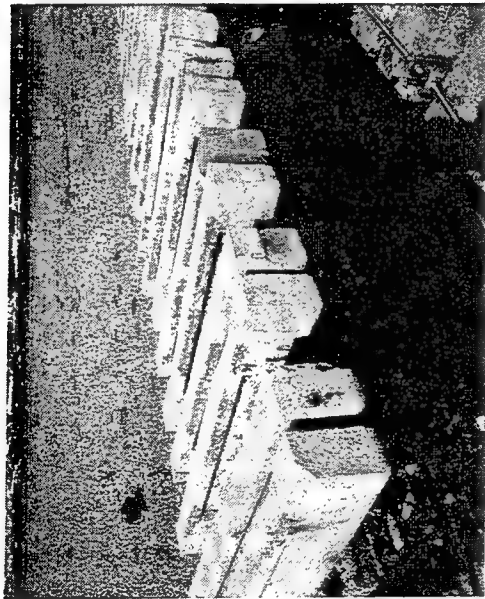
Fig. 2B

1972 - 20 beams

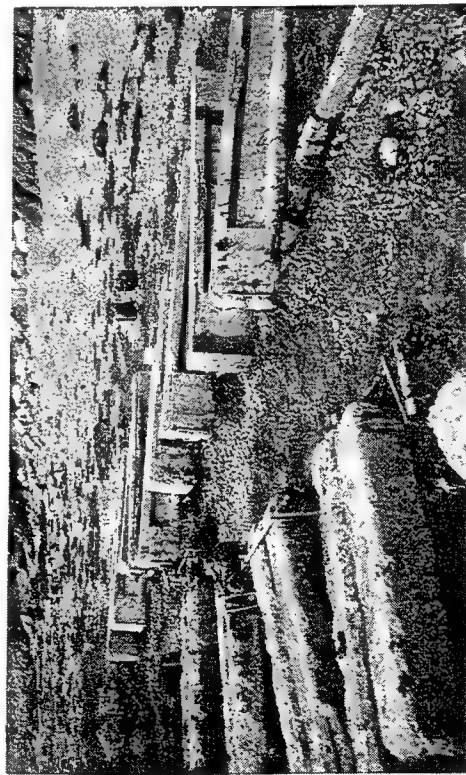
Fig. 2D

1990 - 9 beams remaining - 3 removed for autopsy at WES in 1984

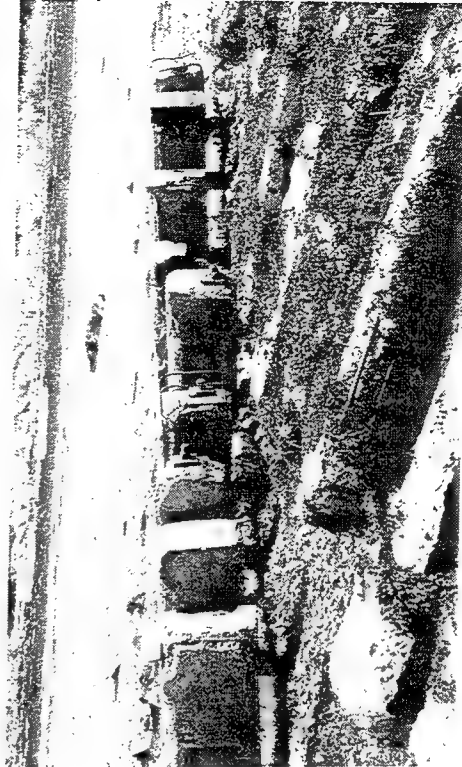
Fig. 2E

1994 - 9 post-tensioned beams at Treat Island

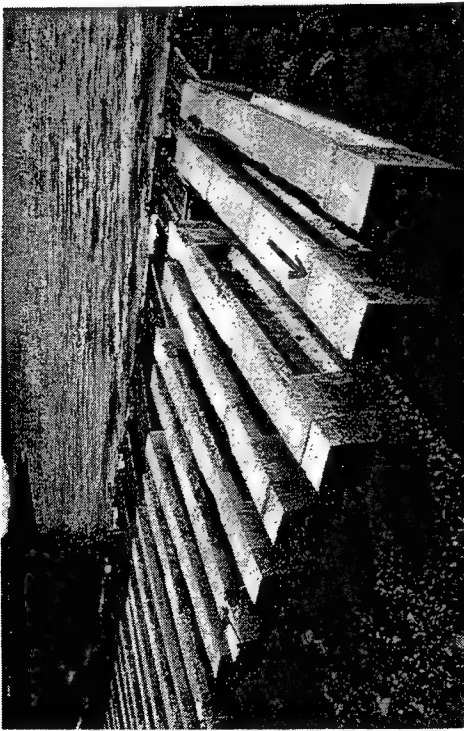
Fig. 5-1A

Beam 2 - Looking seaward - 1972

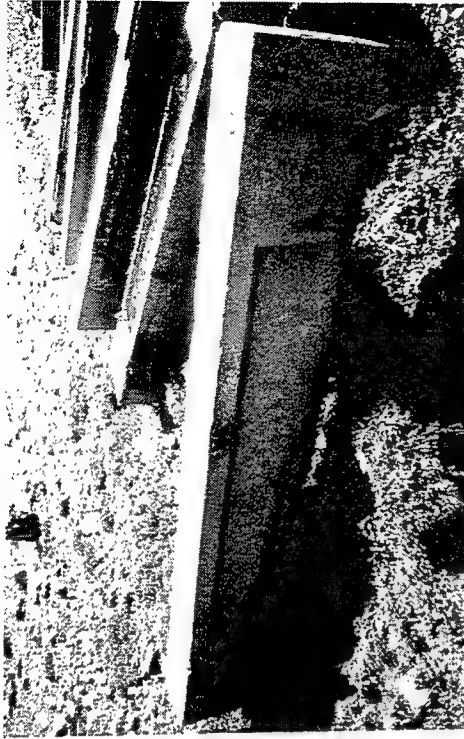
Fig. 5-1B

Beam 2 - 1978

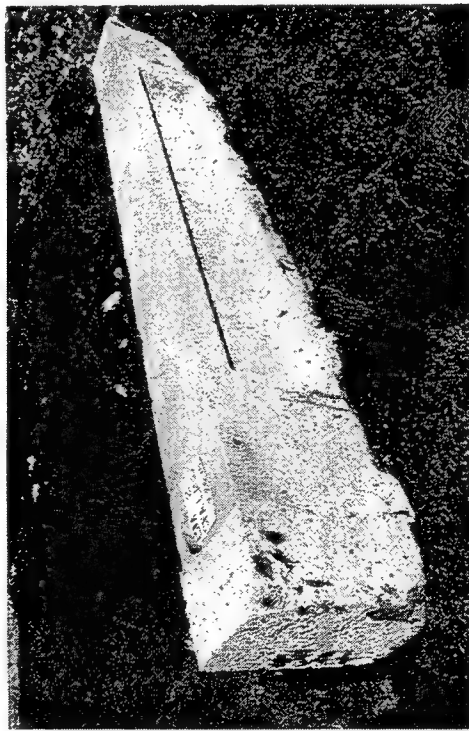
Fig. 5-1C

Beam 2 - 1978

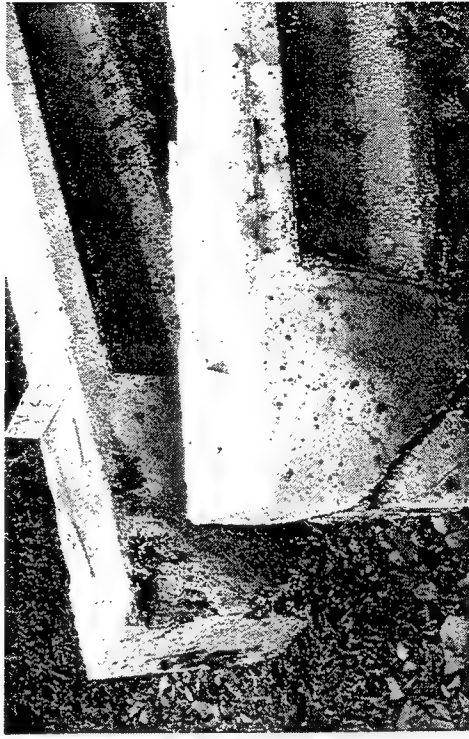
Fig. 5-1D

Beam 2 - Landward end - 1982

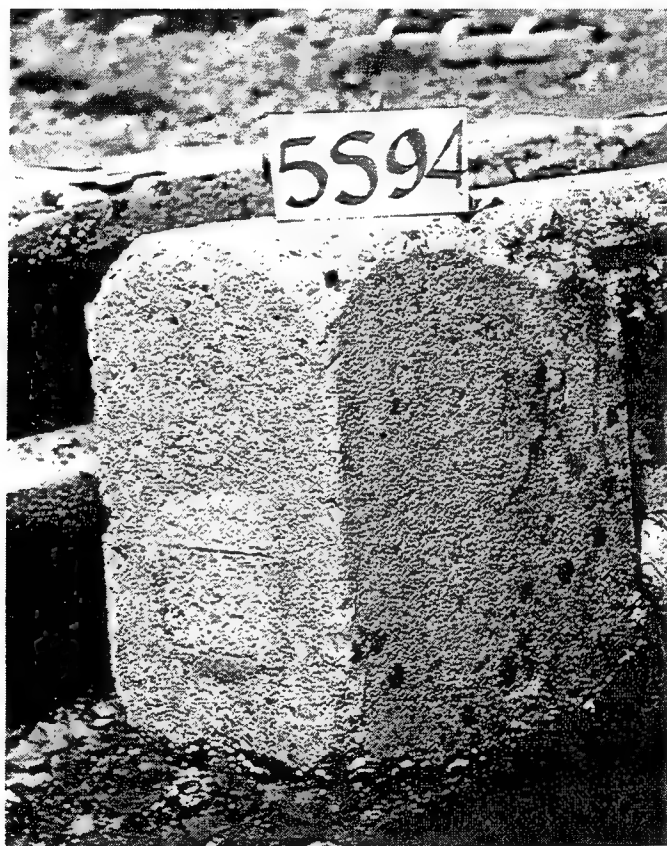
Fig. 6B

1. Surface preparation - sandblasted, followed by epoxy-resin adhesive, 2 ends (Fig. 6B).

Beam 5 - Seaward end - 1994

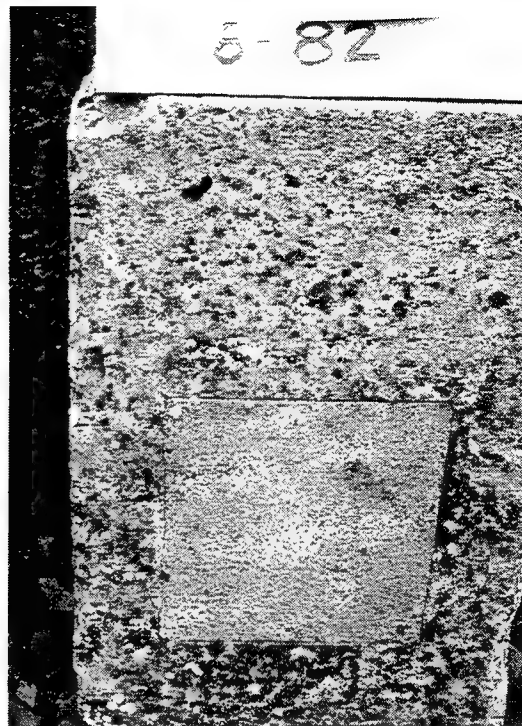
Fig. 7-1B

Beam 12 - Seaward end - 1982

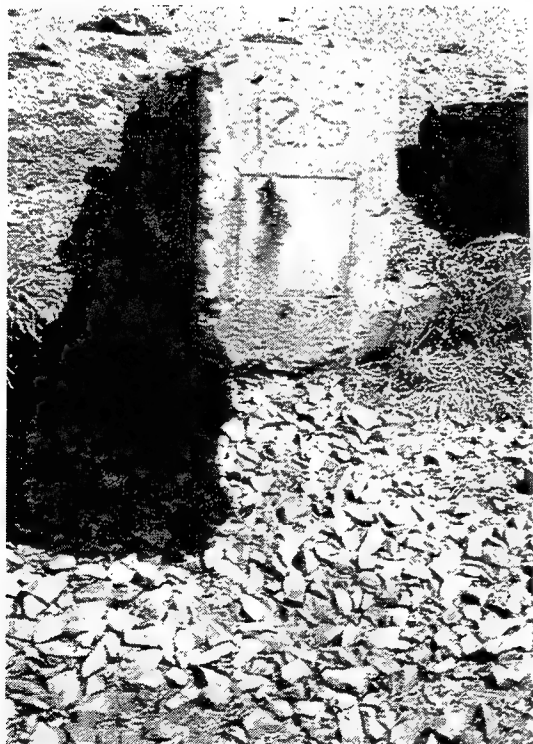
Fig. 7-1C

Beam 12 - Seaward end - 1990

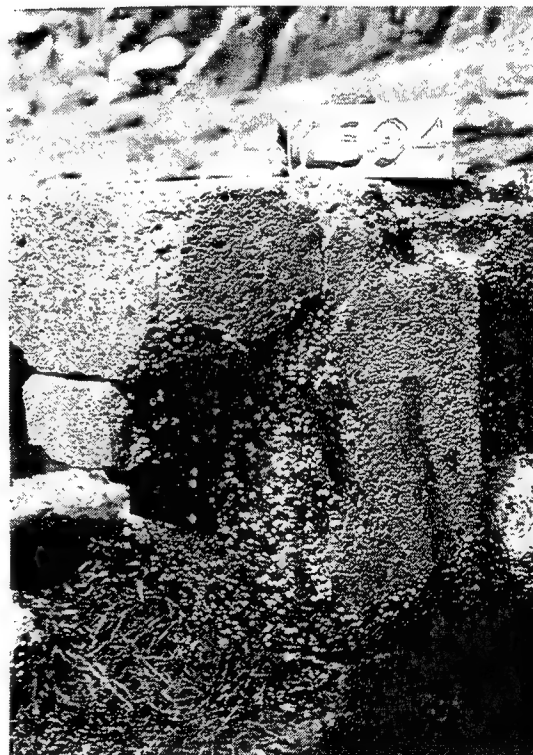
Fig. 7-1D

Beam 12 - Seaward end - 1994

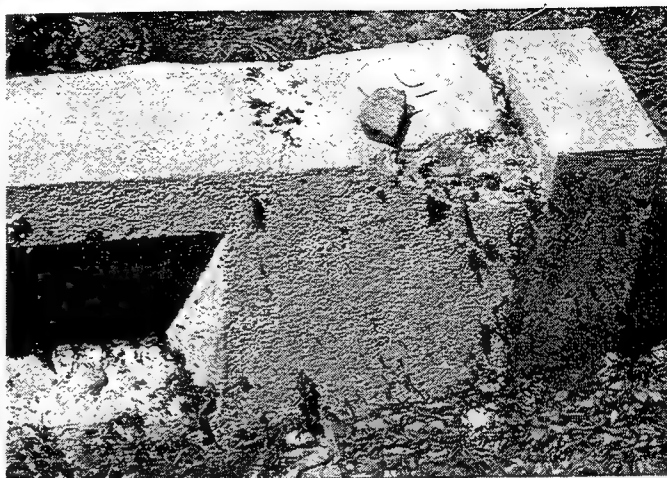
Fig. 8-2F

Beam 16 - Landward end - 1988

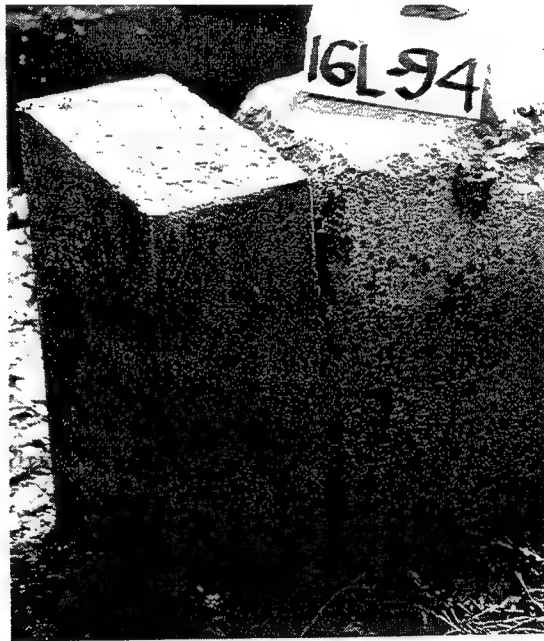
Fig. 8-2H

Beam 16 - Landward end - 1994

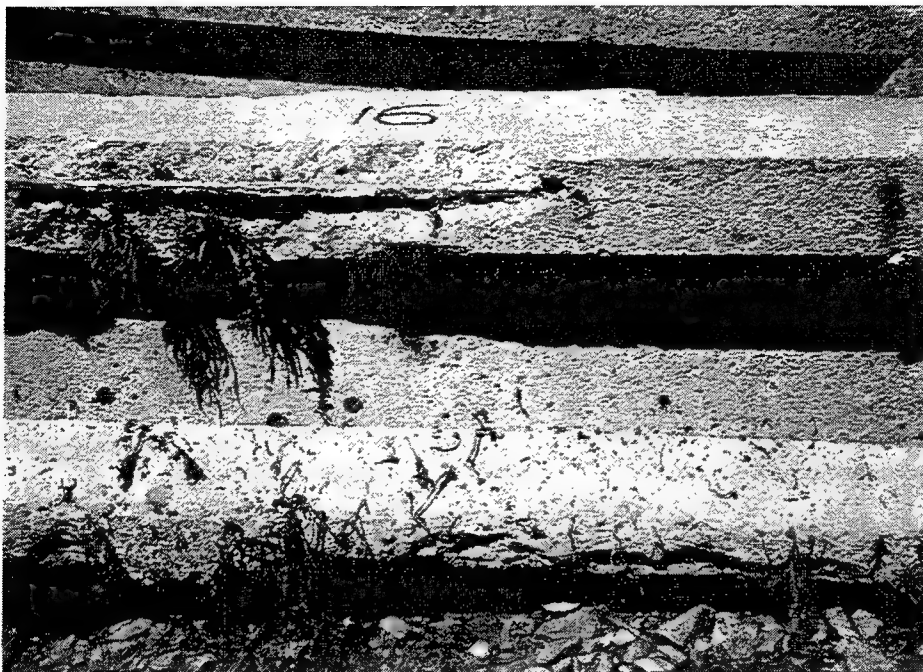
Fig. 8-4M

Beam 16 - 1990

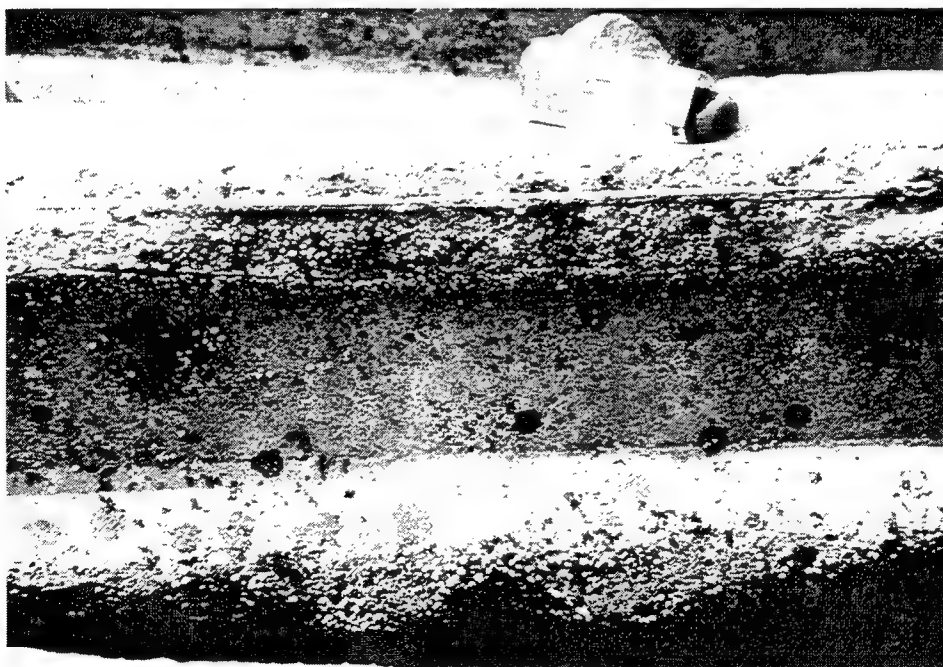
Fig 8-4N

Beam 16 - 1994

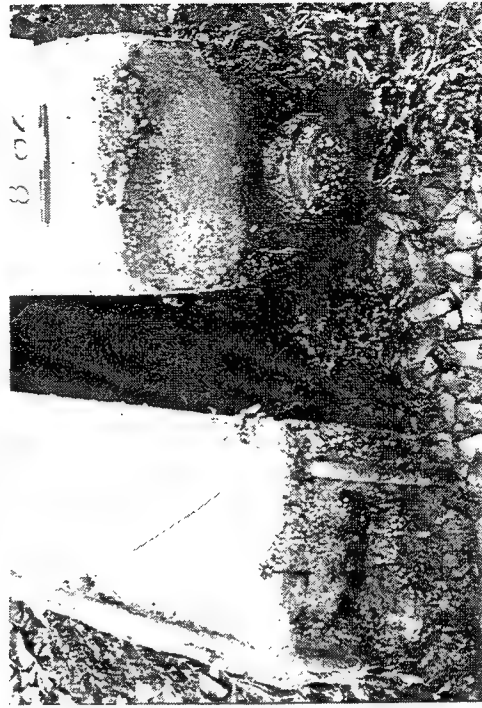
Beam 17 - Landward end - 1982
Before 1984 autopsy
Fig. 9-1D

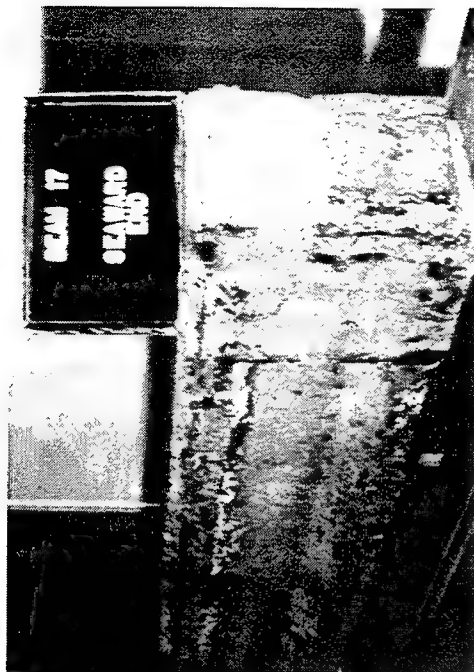
Beam 17 - Landward end - 1984
Prior to autopsy
Fig. 9-2F

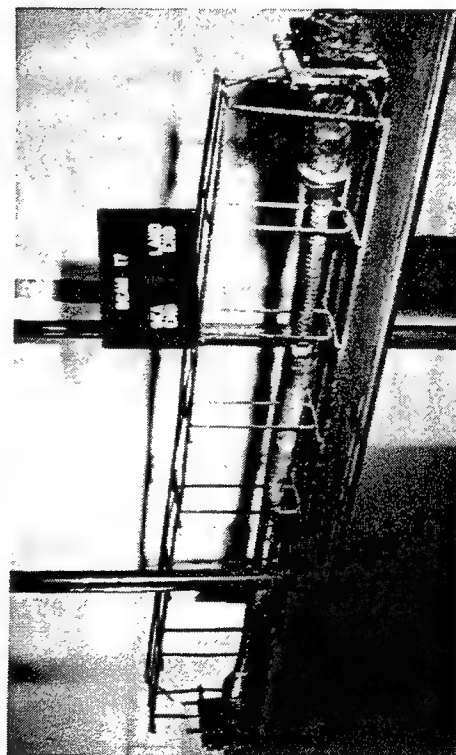
Fig. 9-2G

All beams contained normal reinforcing steel which was provided with a nominal 3/4-in. (19-mm) concrete cover. The details of reinforcement are shown in Fig. 3 and Table 4 of Appendix A. Figure 9-2G shows a typical reinforcing cage removed from an autopsied beam.

Beam 17 - Reinforcement cage - 1984

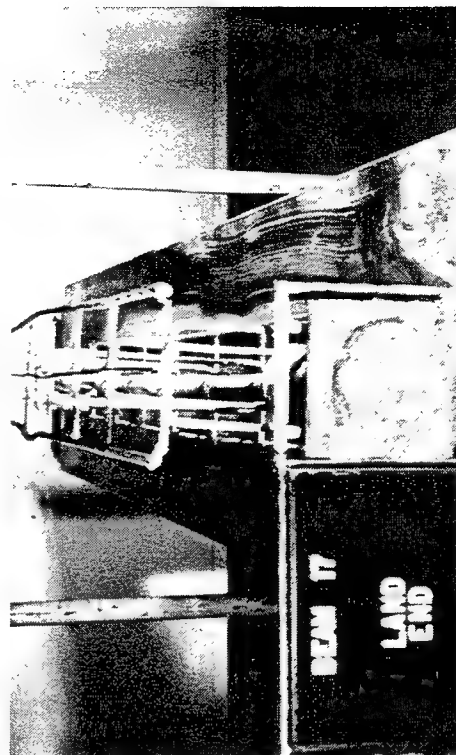
Fig. 9-2H

Beam 17 - Landward end reinforcement, anchorage - 1984

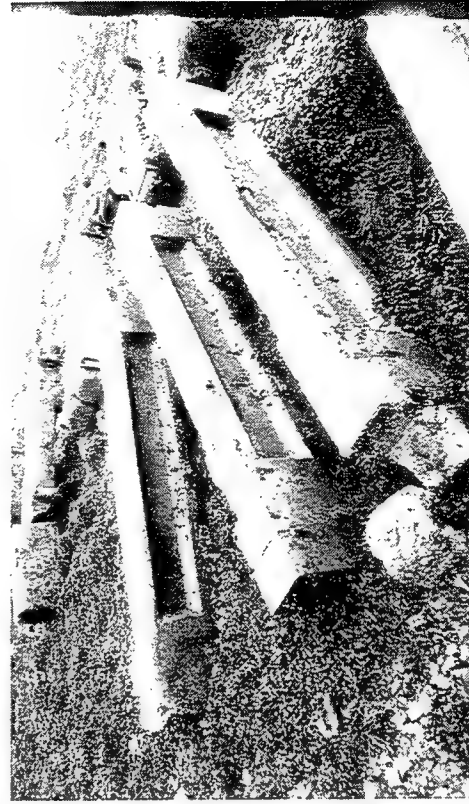
Beam 4 - Landward end - 1982
Fig. 10-1D
